Detailed Project Report
Beaver Brook, Keene, New Hampshire

Supporting Documentation

Flood Damage Reduction

FEBRUARY 1984

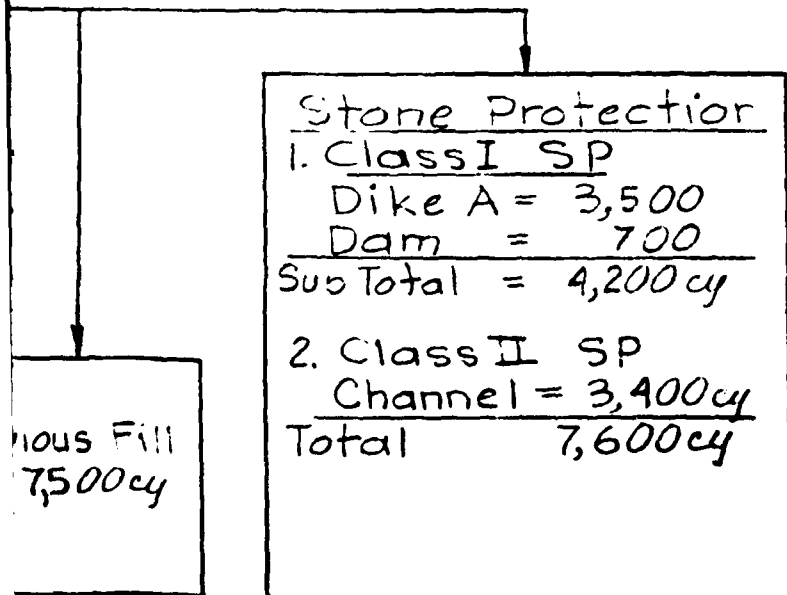
DEPARTMENT OF THE ARMY NEW ENGLAND DIVISION CORPS OF ENGINEERS WALTHAM, MASS	
JH DES. BY	BEAVER BROOK L.P.P. MATERIALS USAGE CHART (PRELIMINARY)
JD CHK. BY	
JH CHK. BY	
GEOTECH. ENG. BR.	SCALE:
SK. NO.	DATE: 2/16/83
